# **Pre-Purchase Report of Marine Survey**

## **"Worth The Wait"**

**2022 33' Grady White Freedom 335**

**Date Of Survey:** Inspection performed on: 10/16/25 with Report submitted on: 10/20/25

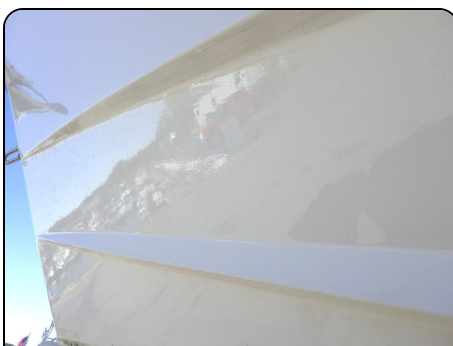
The exterior of the vessel appeared to be well kept and free from any excessive wear. There were areas gel coat blemishes at the bow, port and starboard sides, where it appeared there was a gel coat repair at the leading edges of the chines and the strakes. Some overspray and drips were observed, as well as some "print-through" of the underlying material beneath the gel coat in the area on the starboard side. No obvious signs of fiberglass repairs were sighted from either inside or outside the vessel.

Port bow gel coat

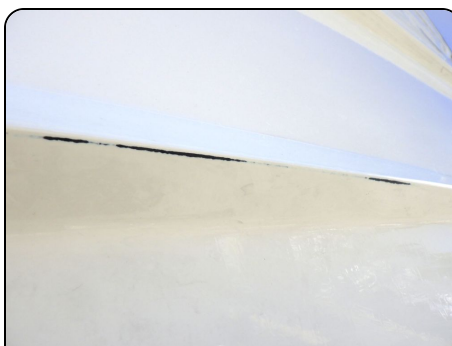
Starboard side print-through

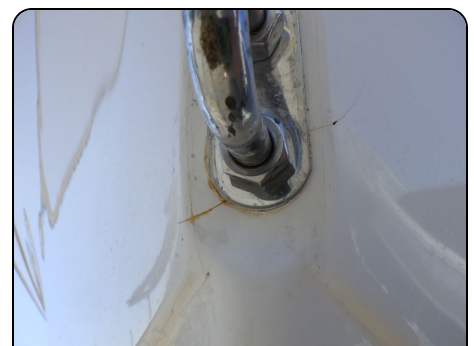
The bow tow eye was showing some stress cracks emanating from the hardware, possibly from a minor impact.

Bow tow eye with gel coat cracks

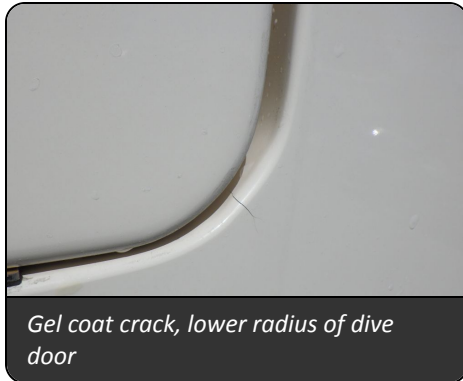
The dive door showed a small gel coat crack emanating from the lower radius and there were elevated conductivity readings detected, possibly indicating moisture intrusion. No signs of delamination were found when tested. It has been the Surveyor's experience that stress cracking in this area are common.

*Gel coat crack, lower radius of dive door*

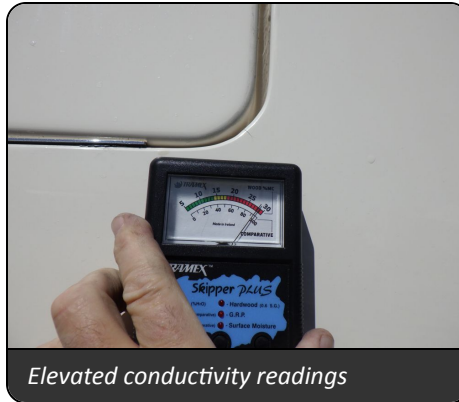
*Elevated conductivity readings*

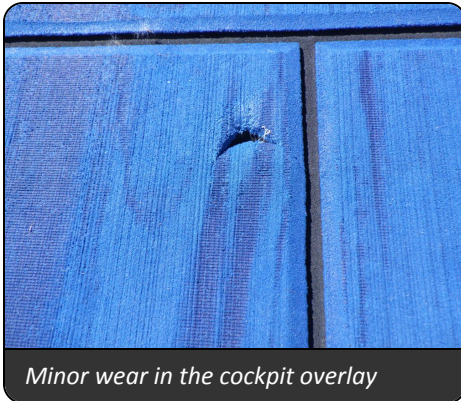
*Minor wear in the cockpit overlay*

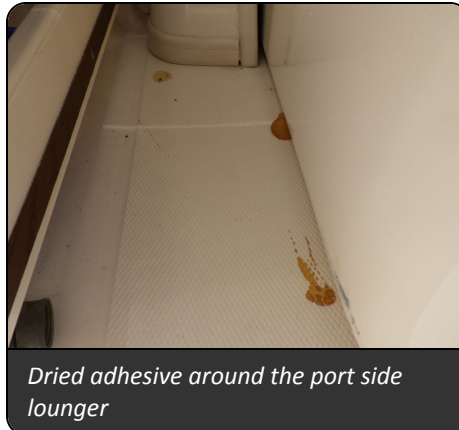
Composite mat deck overlays throughout the cockpit and bow decks. The deck overlays showed only minor wear & tear, and were generally in serviceable condition with only a minor cut sighted in the cockpit. A section of deck was observed to have had glue applied to the fiberglass non-skid around the port side adjustable lounge seat (its possible there was a section over overlay applied here and later removed as it was interfering with the adjustable seating).

*Dried adhesive around the port side lounge*

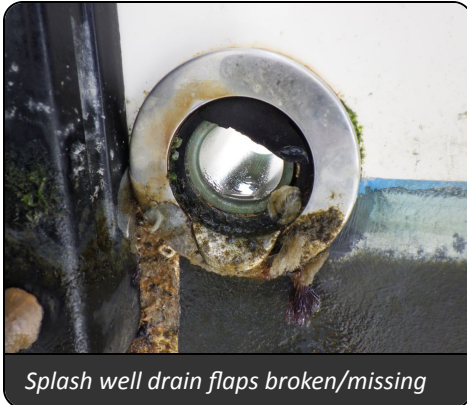
Self bailing deck drains at the port & starboard aft cockpit corners, observed to be clear of debris.  
Two of the splash well drain anti-back flow flaps were observed to be broken/missing at the transom.

*Splash well drain flaps broken/missing*

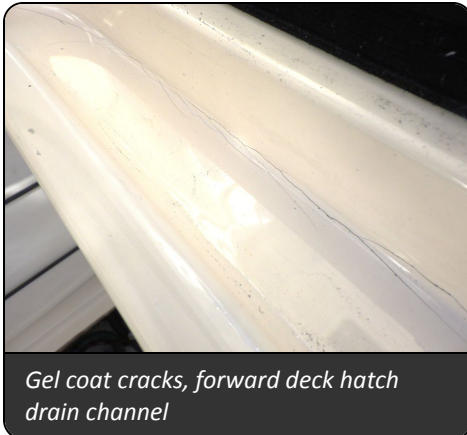
Cored fiberglass deck hatches with struts, found to be in serviceable condition. There were some hairline cracks in the gel coated drain channel sighted in the forward hatch.

*Gel coat cracks, forward deck hatch drain channel*

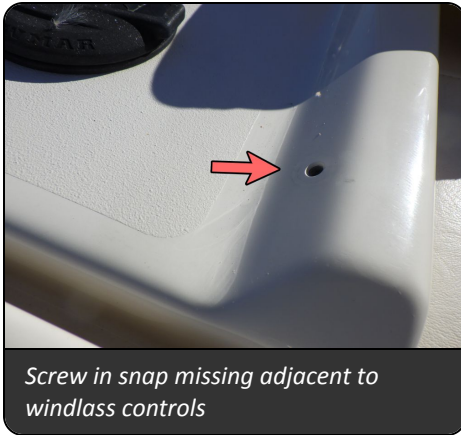
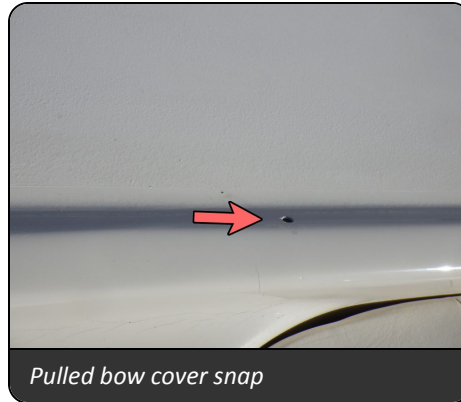
Vinyl cockpit and bow covers in serviceable condition without any significant wear and tear. There were some pulled threaded snaps observed at the bow.

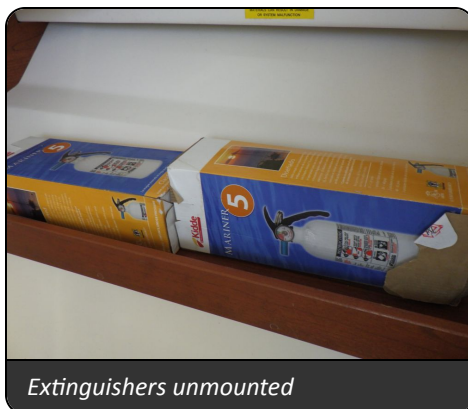
There were three (3) 2lb dry chemical single use extinguishers sighted on board the vessel. One was mounted in the cockpit on the starboard side, found to be in serviceable condition and showing a full charge on the gauge. The other two extinguishers were still in their original manufacturer packaging, manufactured in 2021 and showing a full charge, unmounted and stowed in the head compartment.

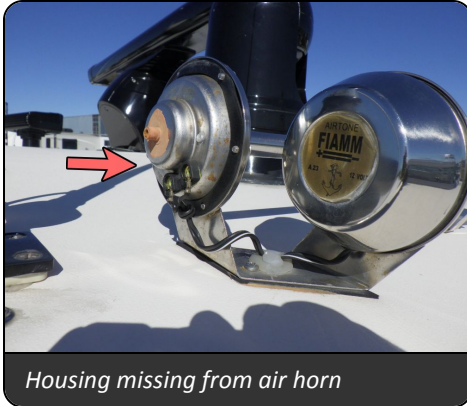
12 volt DC electric, dual trumpet Airtone Fiamm air horn. The horn powered up when tested. One of the trumpet housing covers was observed to be missing.

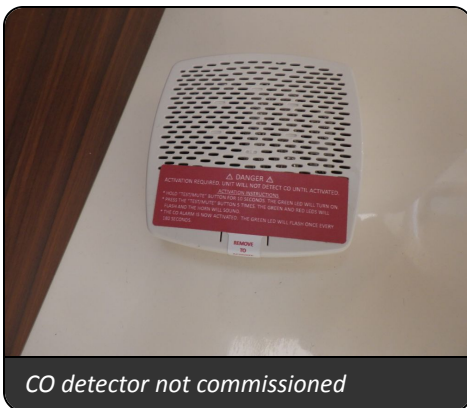
The cabin was fitted with a CO detector, however it had not yet been commissioned by removing the manufacturer tags. ABYC A-24.5.1 indicates "A carbon monoxide detector shall be installed to monitor the atmosphere in habitable spaces". A habitable space is defined as a space surrounded by permanent structure in which there is provision for sleeping, cooking, eating, washing, navigation or steering. Isolated head compartments, spaces intended exclusively for storage, and engine rooms are not included in this definition.

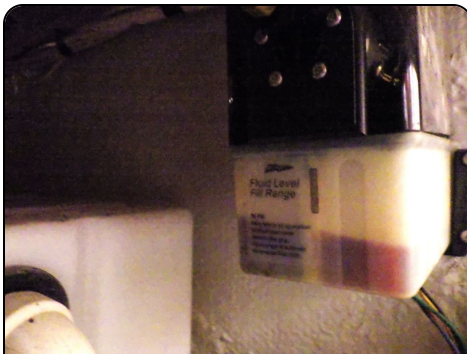
Bennett Marine 12 volt hydro-electric trim tabs with single ram actuators, bilge mounted reservoir, and helm level indicator displays. The rams were found to be securely mounted and in serviceable condition. Trim tab function was demonstrated, in serviceable condition. The fluid level in the reservoir was observed to be low, however no hydraulic leaks were observed.

*Trim tab reservoir was observed to be low*

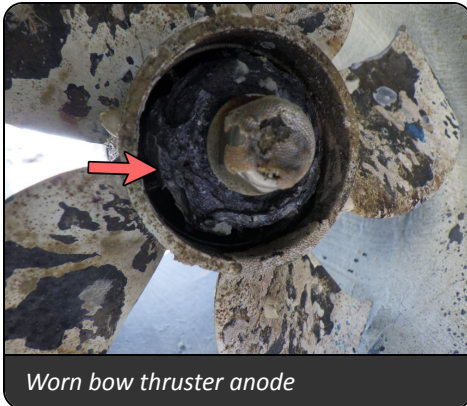
The zinc anodes were showing some wear, most notably at the bow thruster propeller.
