# **Pre-Purchase Report of Marine Survey**

## **"Worth The Wait"**

**2022 33' Grady White Freedom 335**

**Date Of Survey:** Inspection performed on: 10/16/25 with Report submitted on: 10/20/25

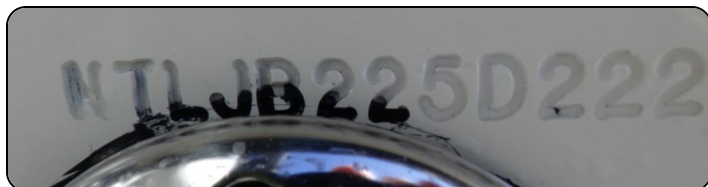
The vessel's HIN (Hull Identification Number) was displayed on the starboard transom and conformed to the standard format mandated by the U.S.C.G.
